AN ASSESSMENT OF ABANDONED MINES IN NORTHERN SASKATCHEWAN

(YEAR 3)

An Assessment of Abandoned Mines in Northern Saskatchewan

File R3278 May 2003

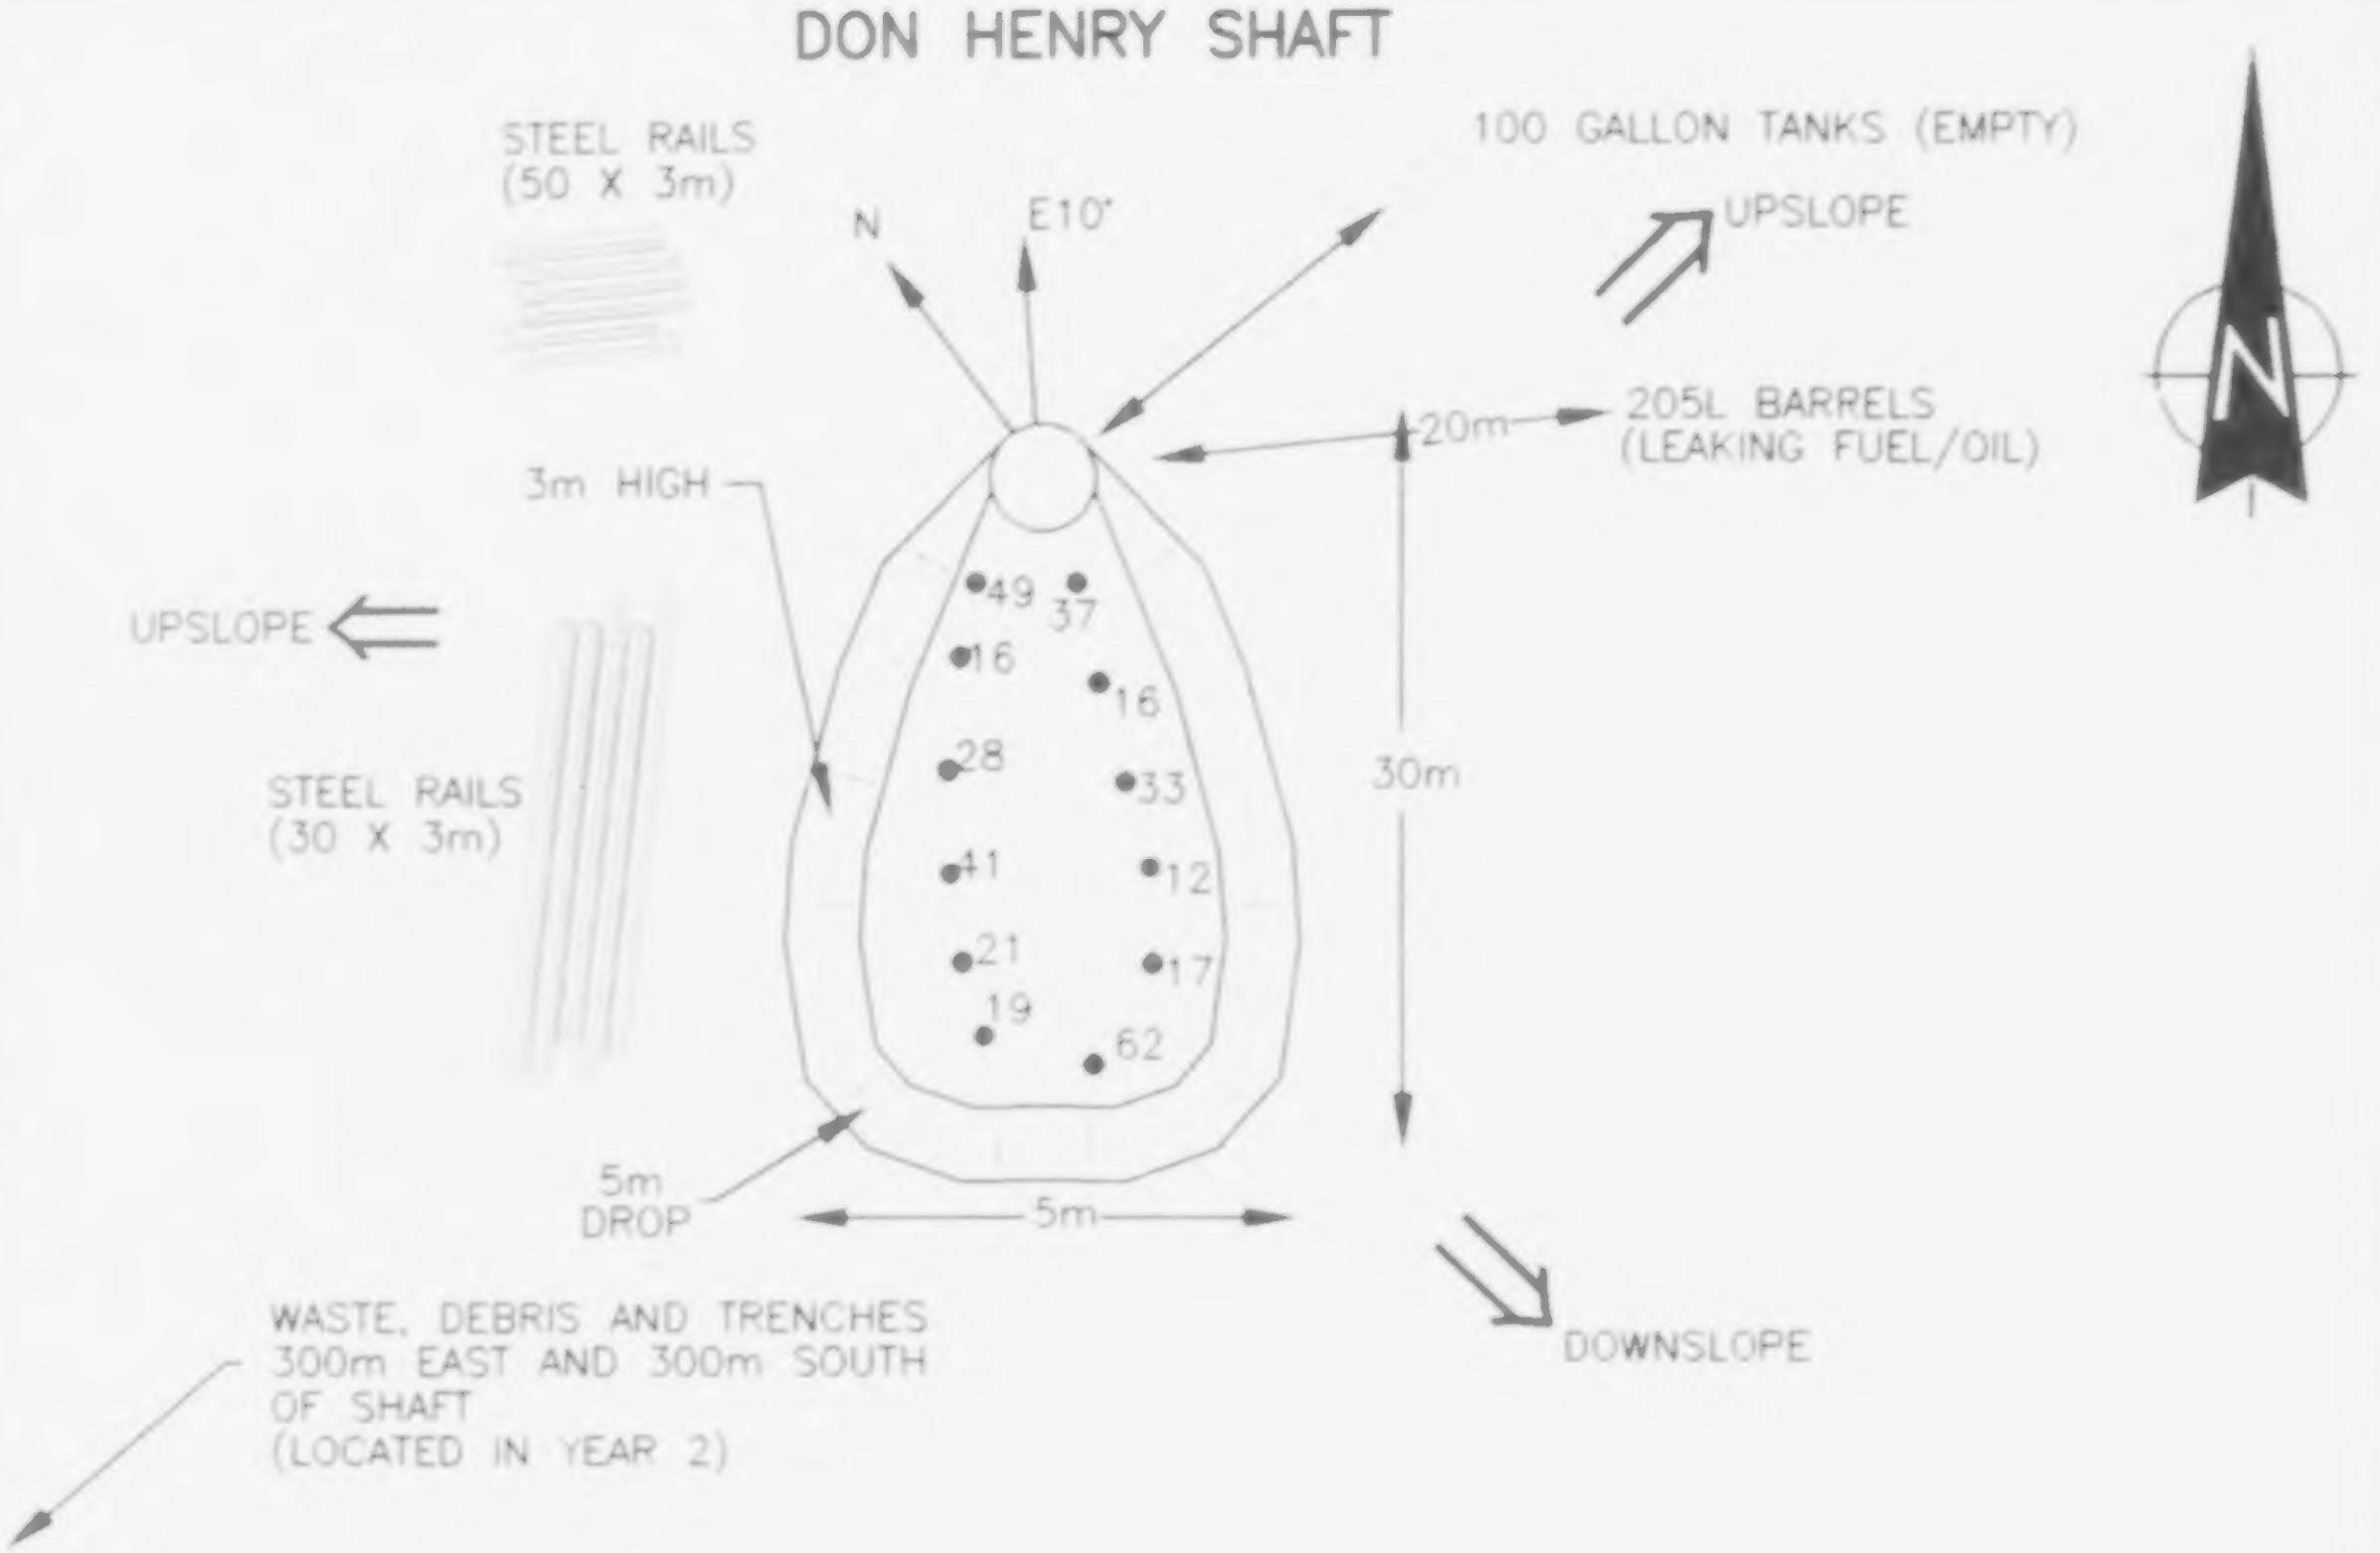
STEEL RAILS
(50 X 3m)
N
E10'
100 GALLON TANKS (EMPTY)
UPSLOPE
N
205L BARRELS
(LEAKING FUEL/OIL)
20m
3m HIGH
UPSLOPE
49
37
16
16
28
33
41
12
21
17
19
62
STEEL RAILS
(30 X 3m)
30m
5m
DROP
5m
DOWNSLOPE
WASTE, DEBRIS AND TRENCHES
300m EAST AND 300m SOUTH
OF SHAFT
(LOCATED IN YEAR 2)

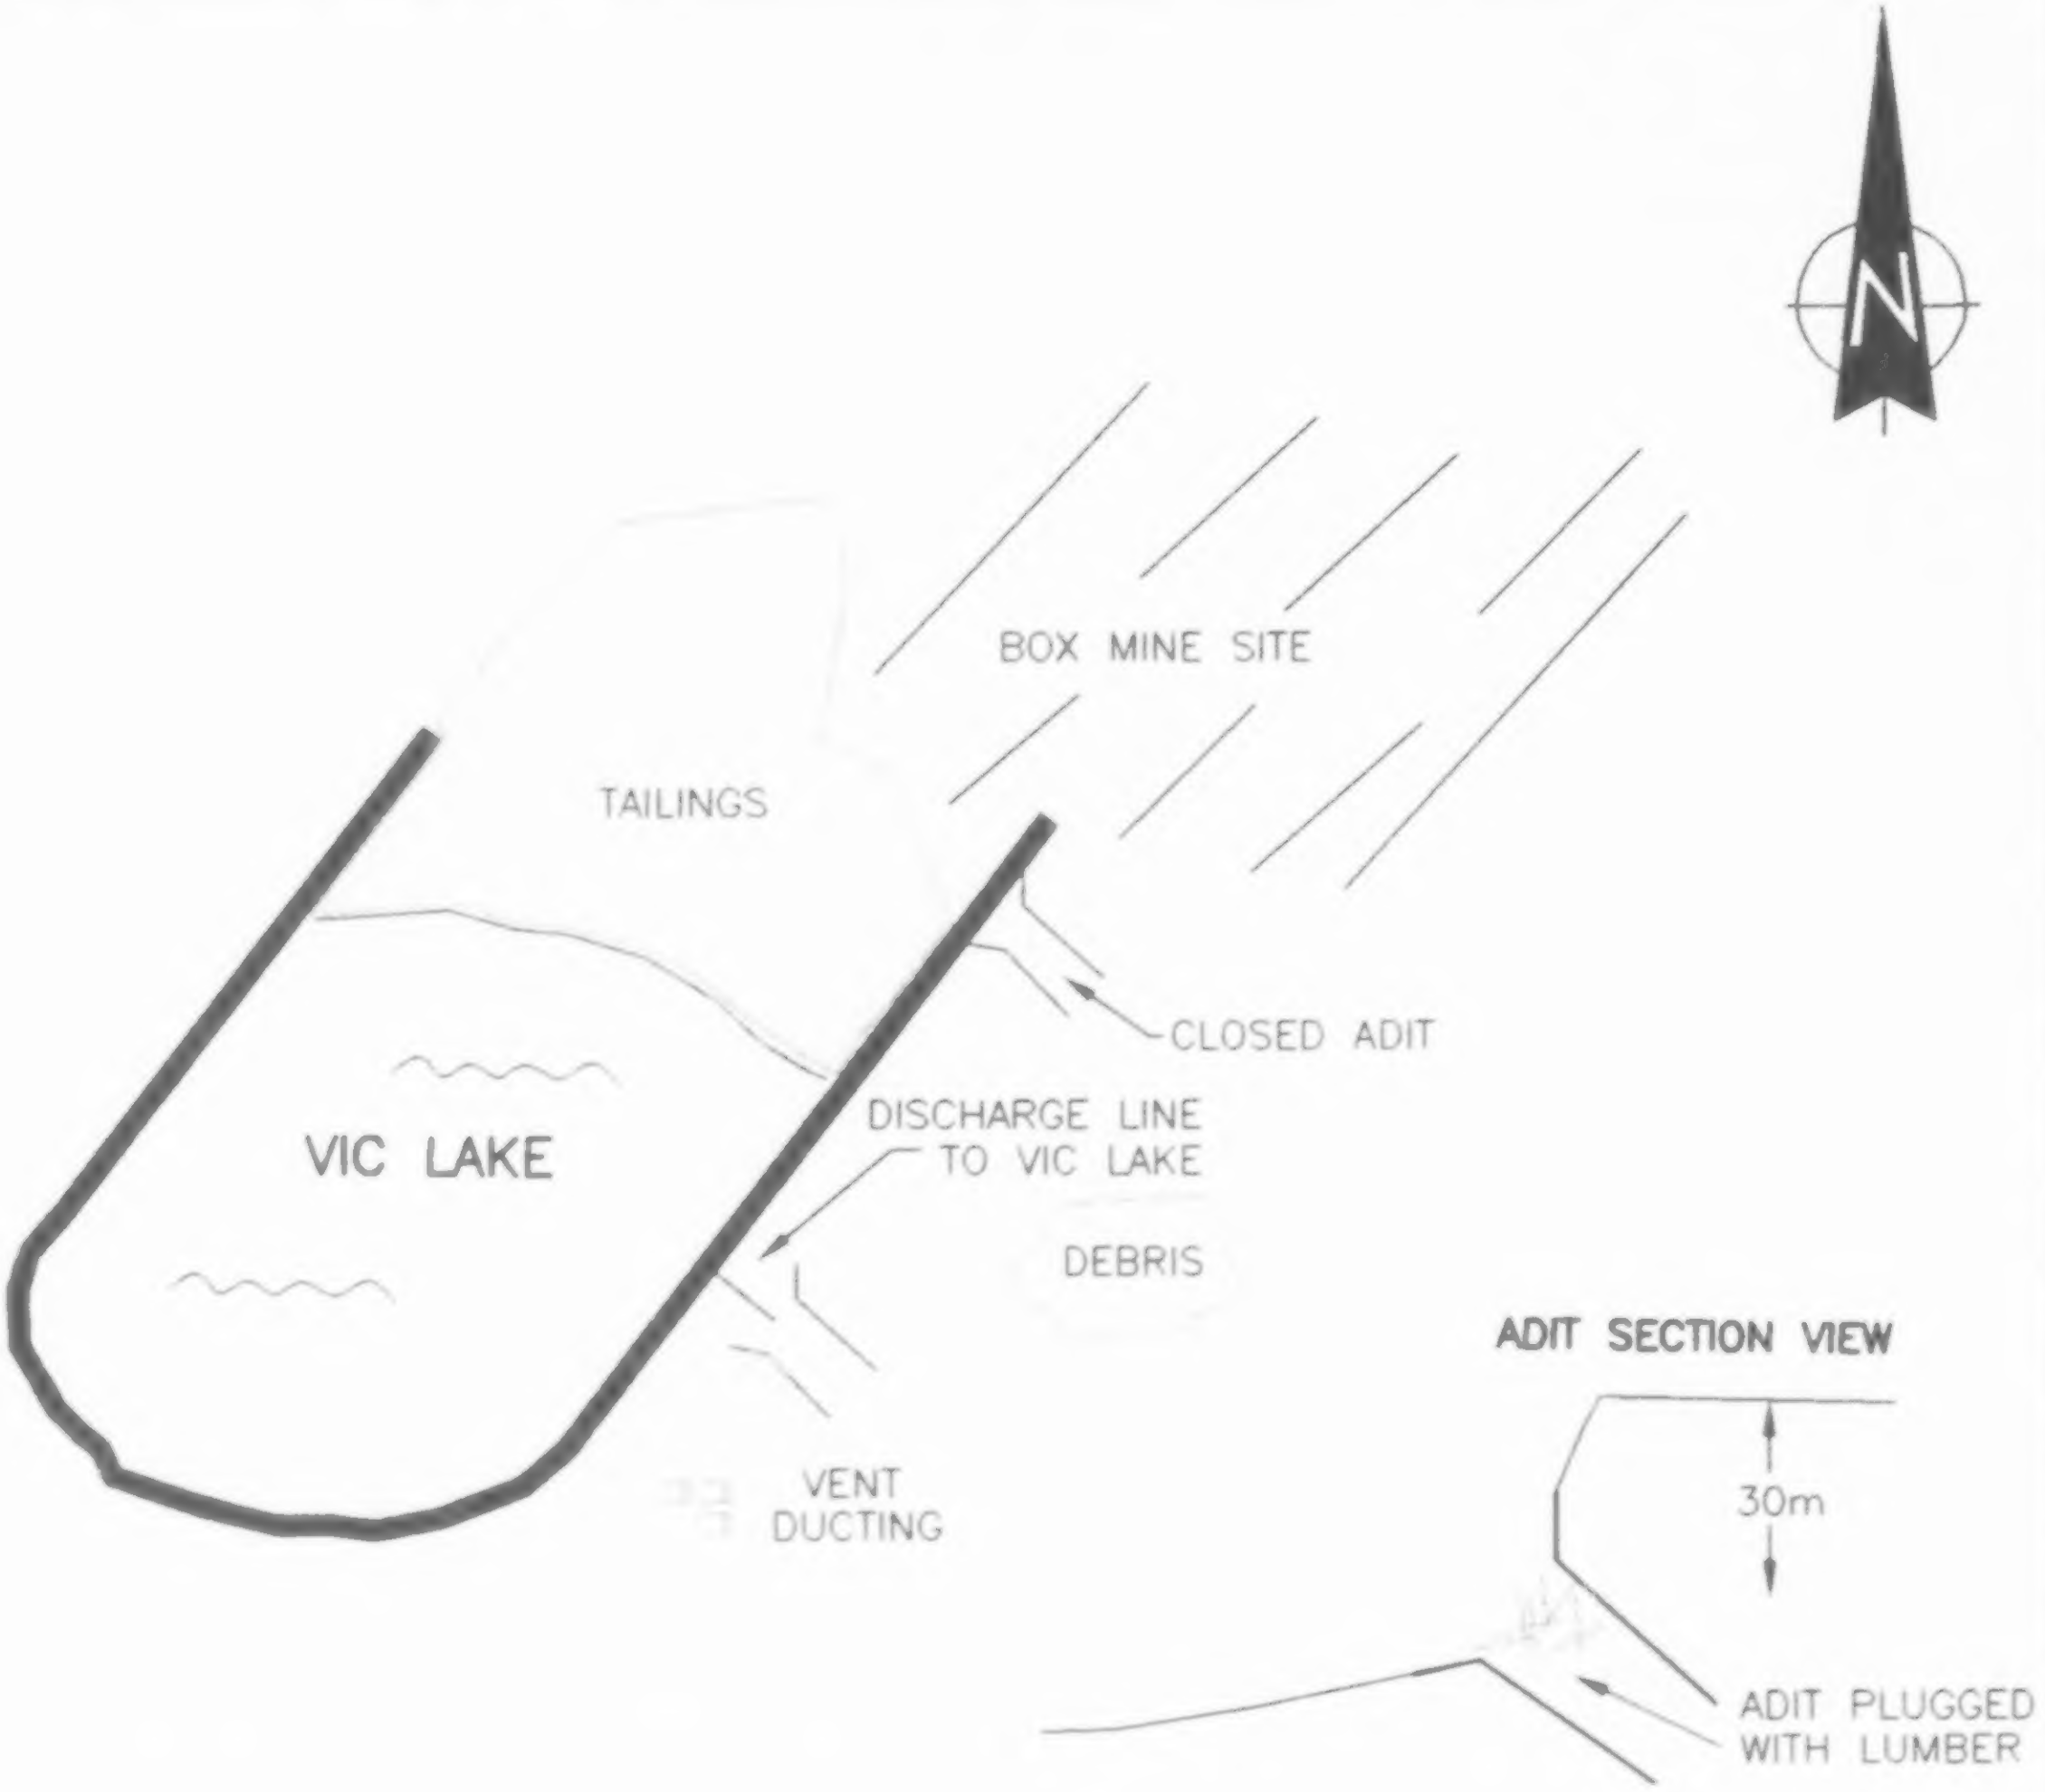
R3278/FIG6.6–2.DWG

The adit appears to be steeply declining although the opening is plugged with lumber. There is a high vertical drop above the adit from the adjacent hillside.

N
BOX MINE SITE
TAILINGS
CLOSED ADIT
VIC LAKE
DISCHARGE LINE TO VIC LAKE
DEBRIS
VENT DUCTING
ADIT SECTION VIEW
30m
ADIT PLUGGED WITH LUMBER

Follow-up work on the adit should be combined with clean-up work at other parts of the property and should include pushing debris into the adit and blasting it closed to permanently seal the opening and to remove the steep rock frame above the adit.

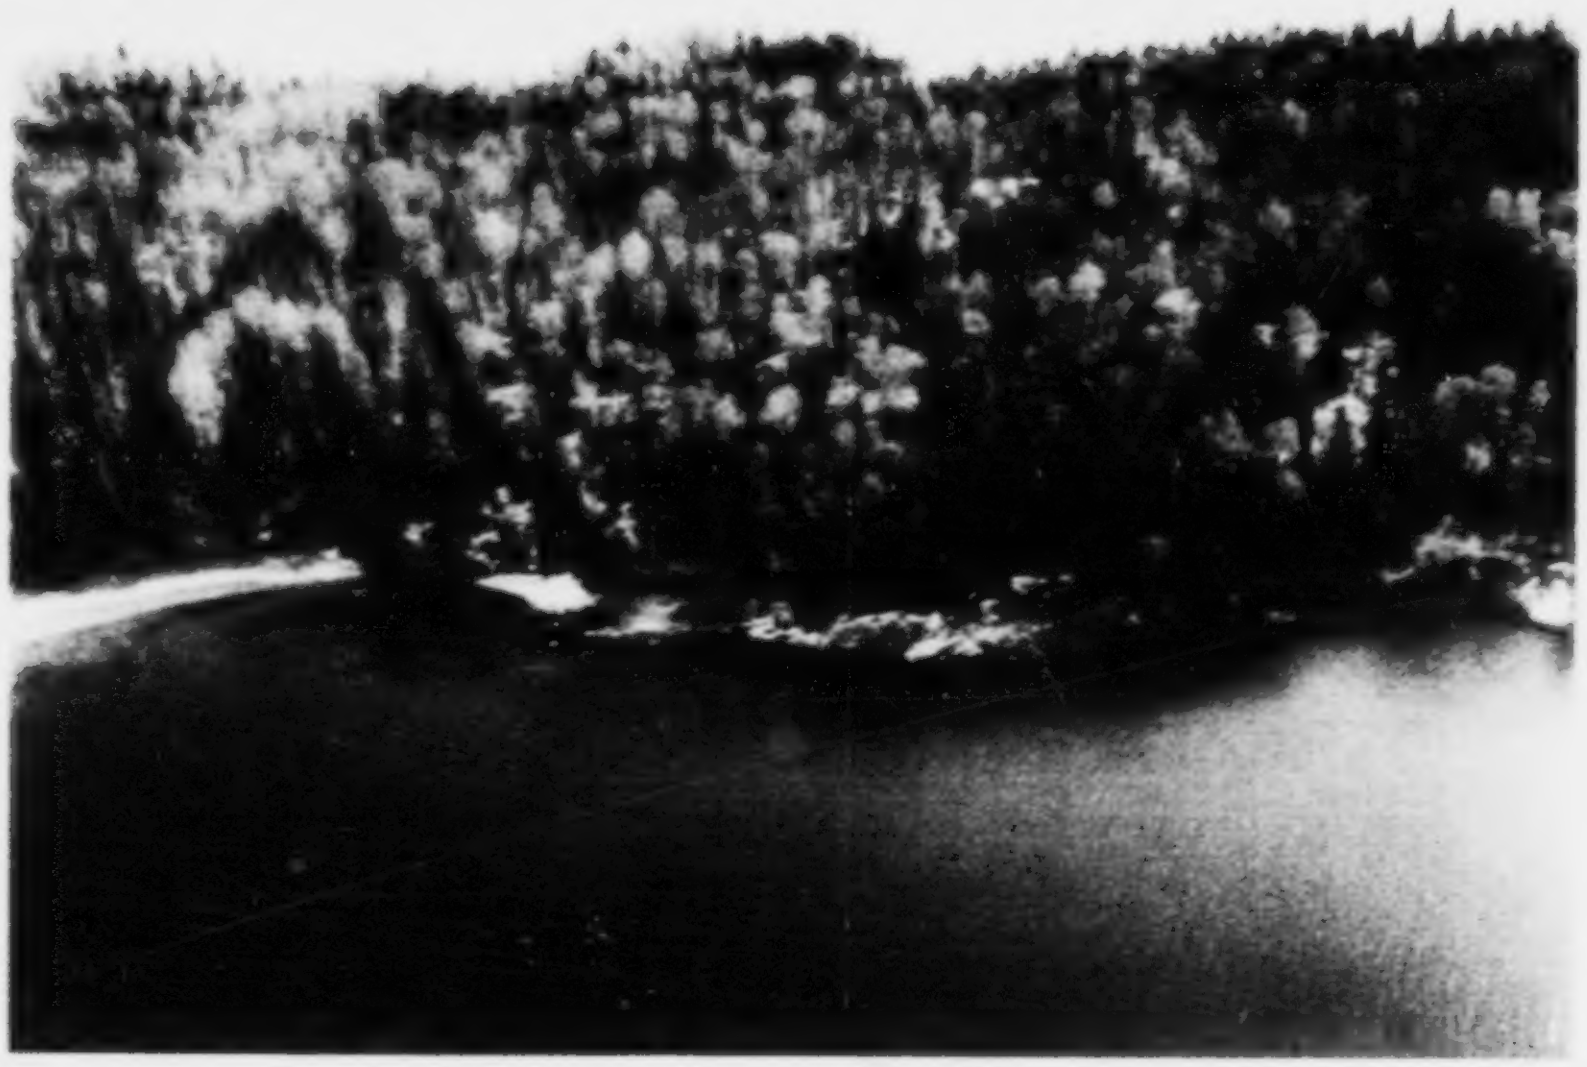
Photograph 6.9-2. Amisk Gold Mine-Trench 'A'-October 19, 2002.

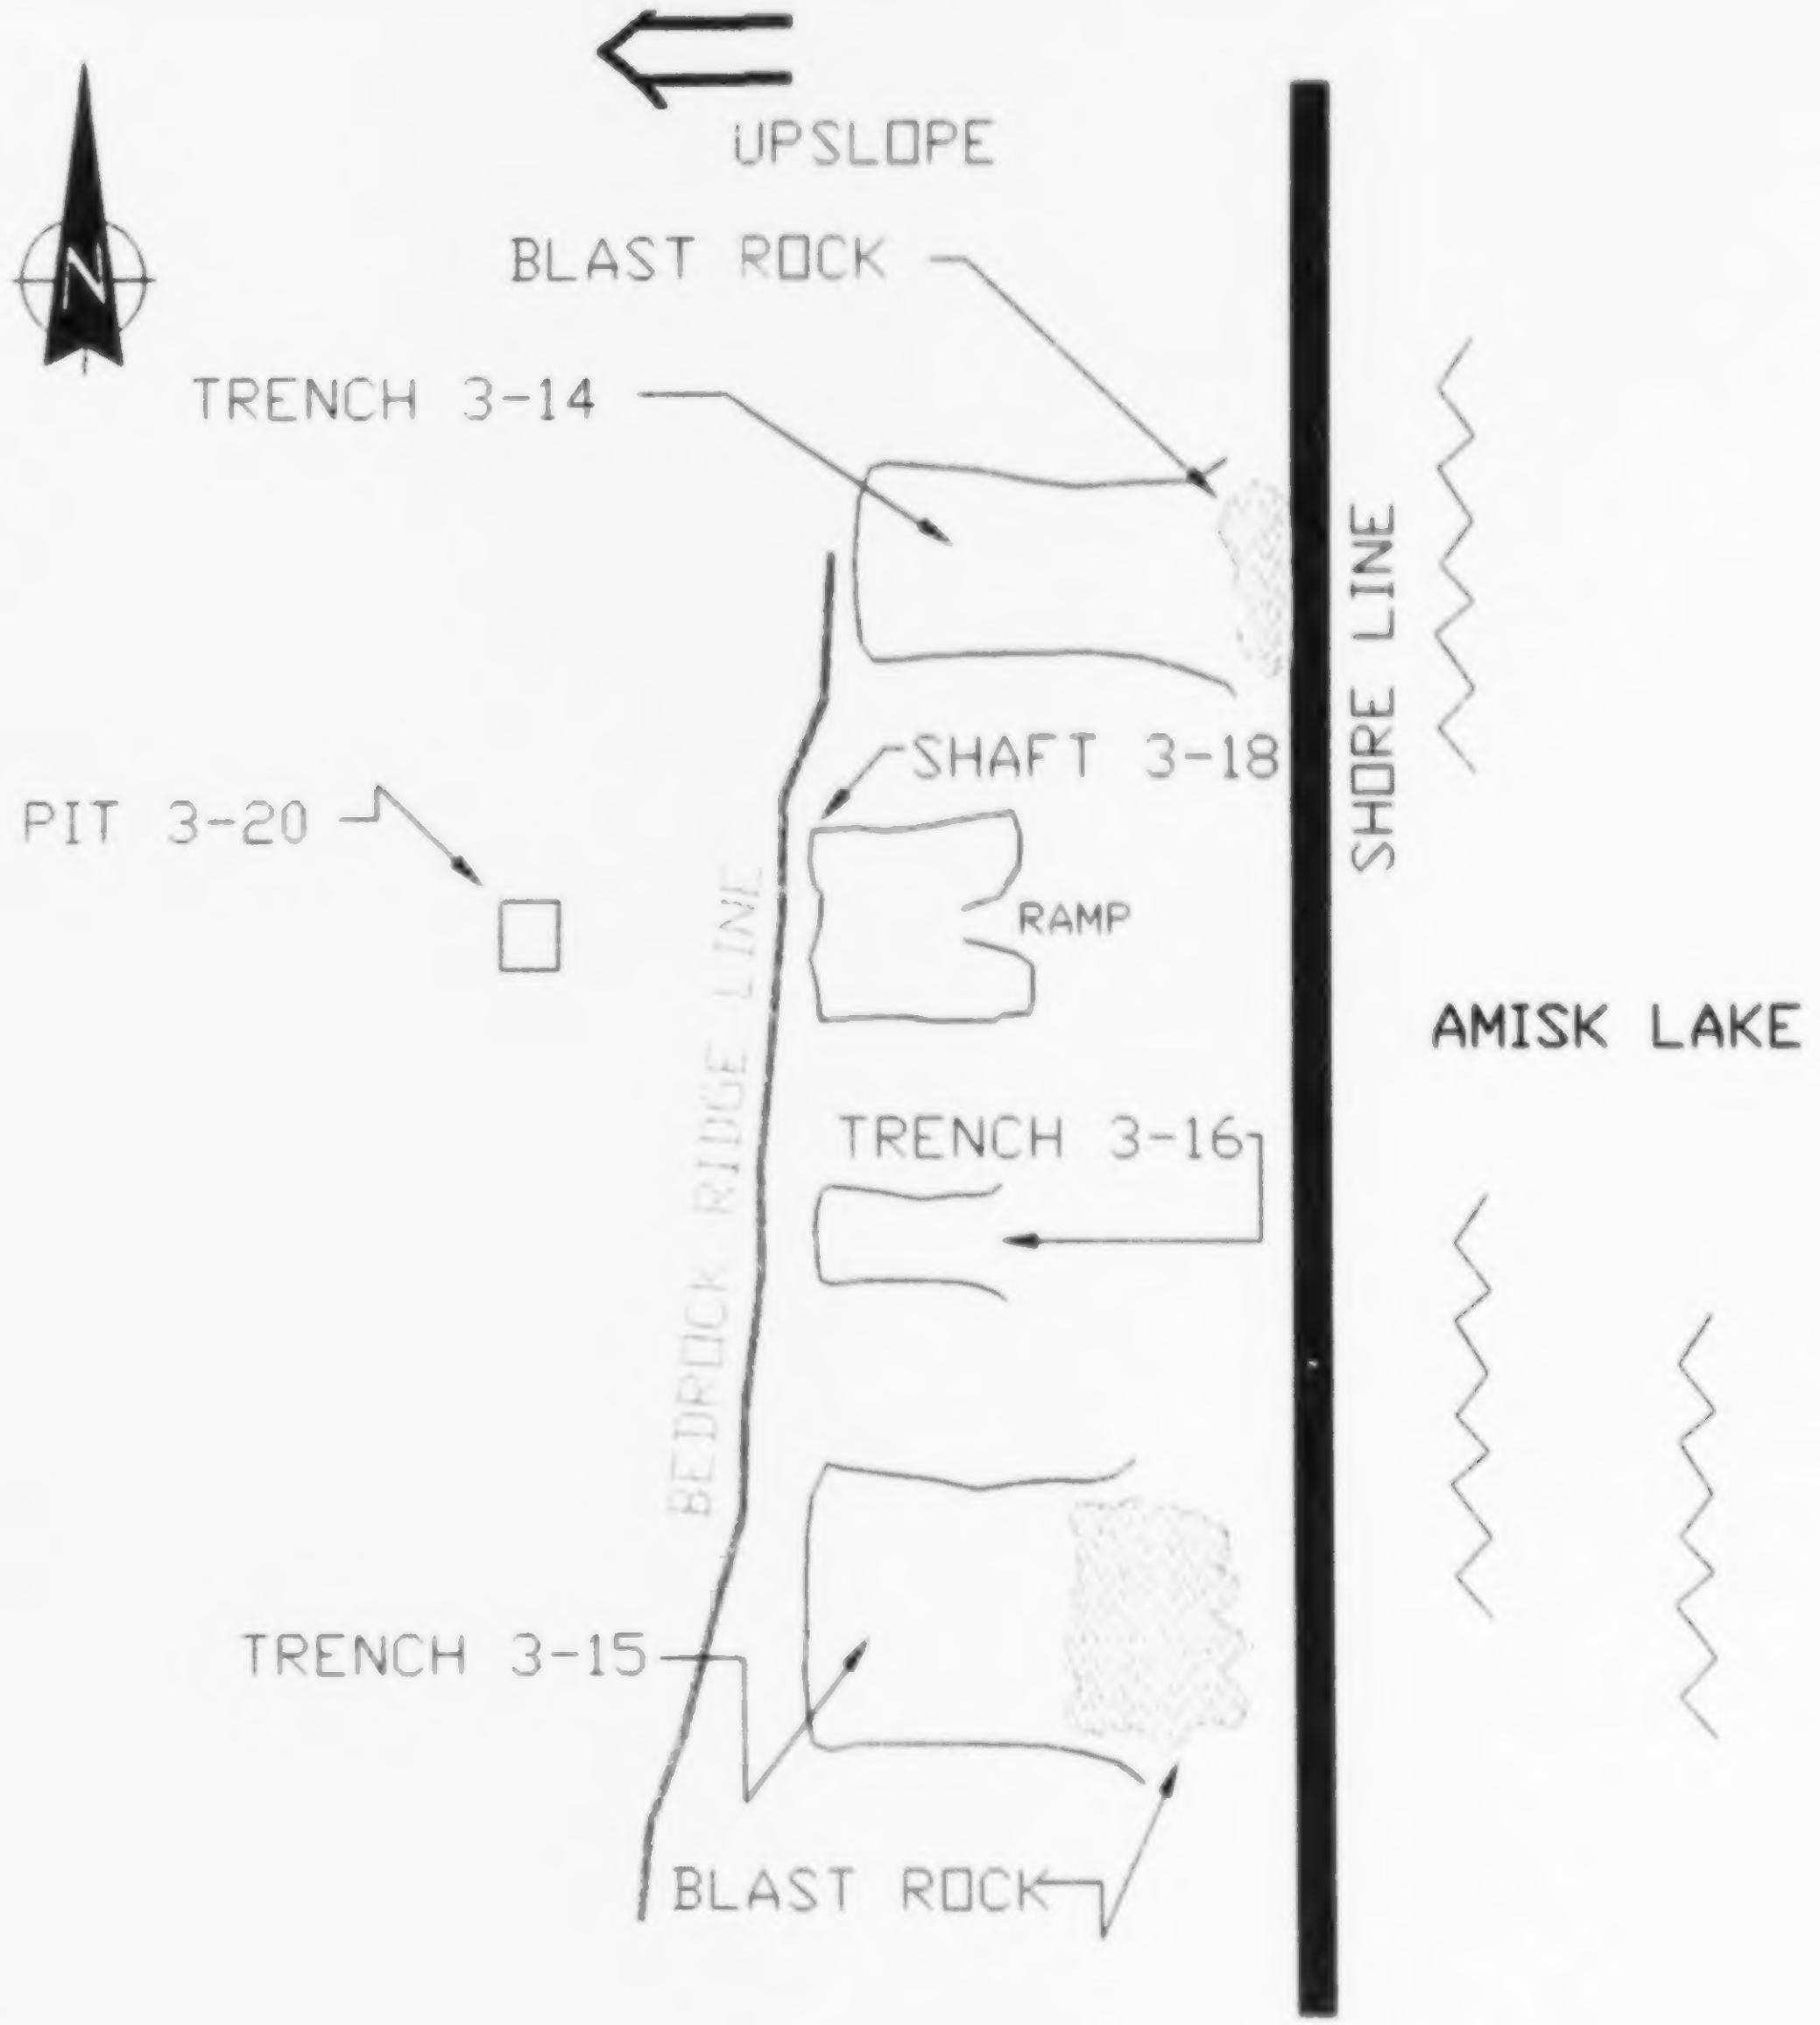
Mine workings consist of three short and moderately deep trenches, a shallow shaft and two small pits exposed over a distance of 30 m along the east slope of the ridge. The workings expose a sulphide stained shear containing 5% massive and disseminated sulfides in a metavolcanic rock. Figure 6.10-2 provides the measured dimensions of each working. For purposes of this investigation, the various workings were assigned letter identifiers, A to E, in order to distinguish them from each other.

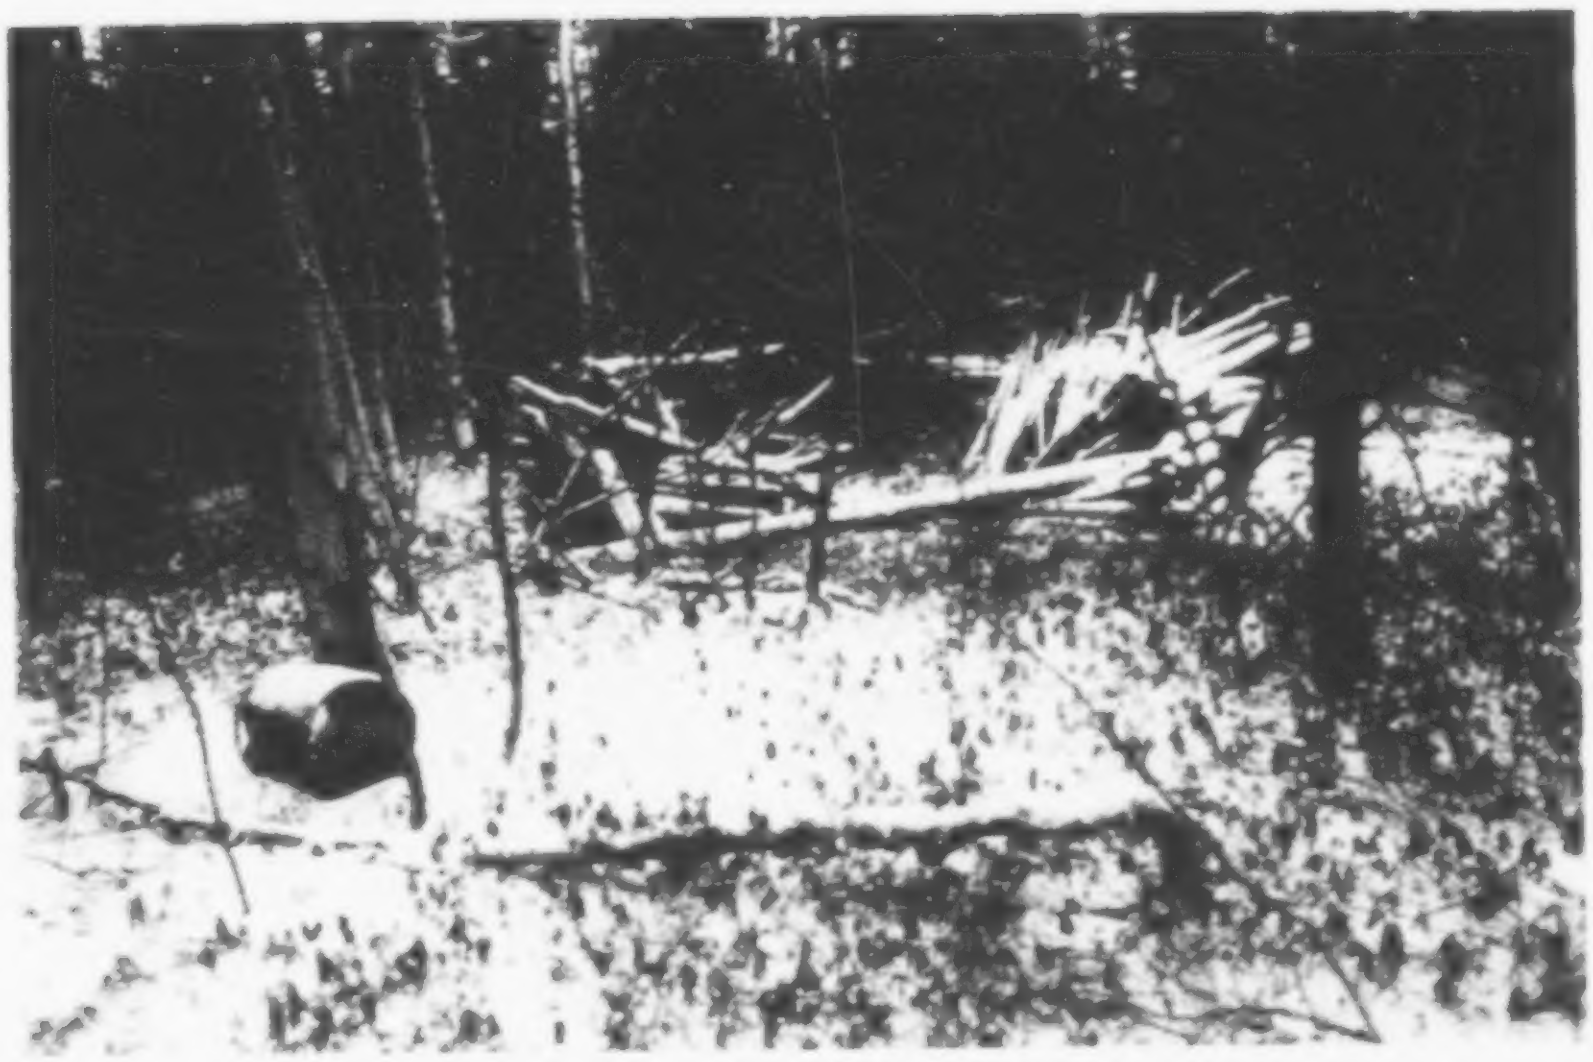
Photograph 6.13-1. SYE/Sunset Exploration Site-Trench 'D'-October 21, 2002.

No follow-up work is required for this site. Given the remoteness and difficulty in accessing the site, it is anticipated there will be minimal people visiting the site. The trenches and pits are relatively shallow and easily recognized when approached, and public safety is therefore not a concern. The excavations appear to be free of accumulated water and excavated rock appears to be generally unmineralized, thus environmental concerns are minimal.

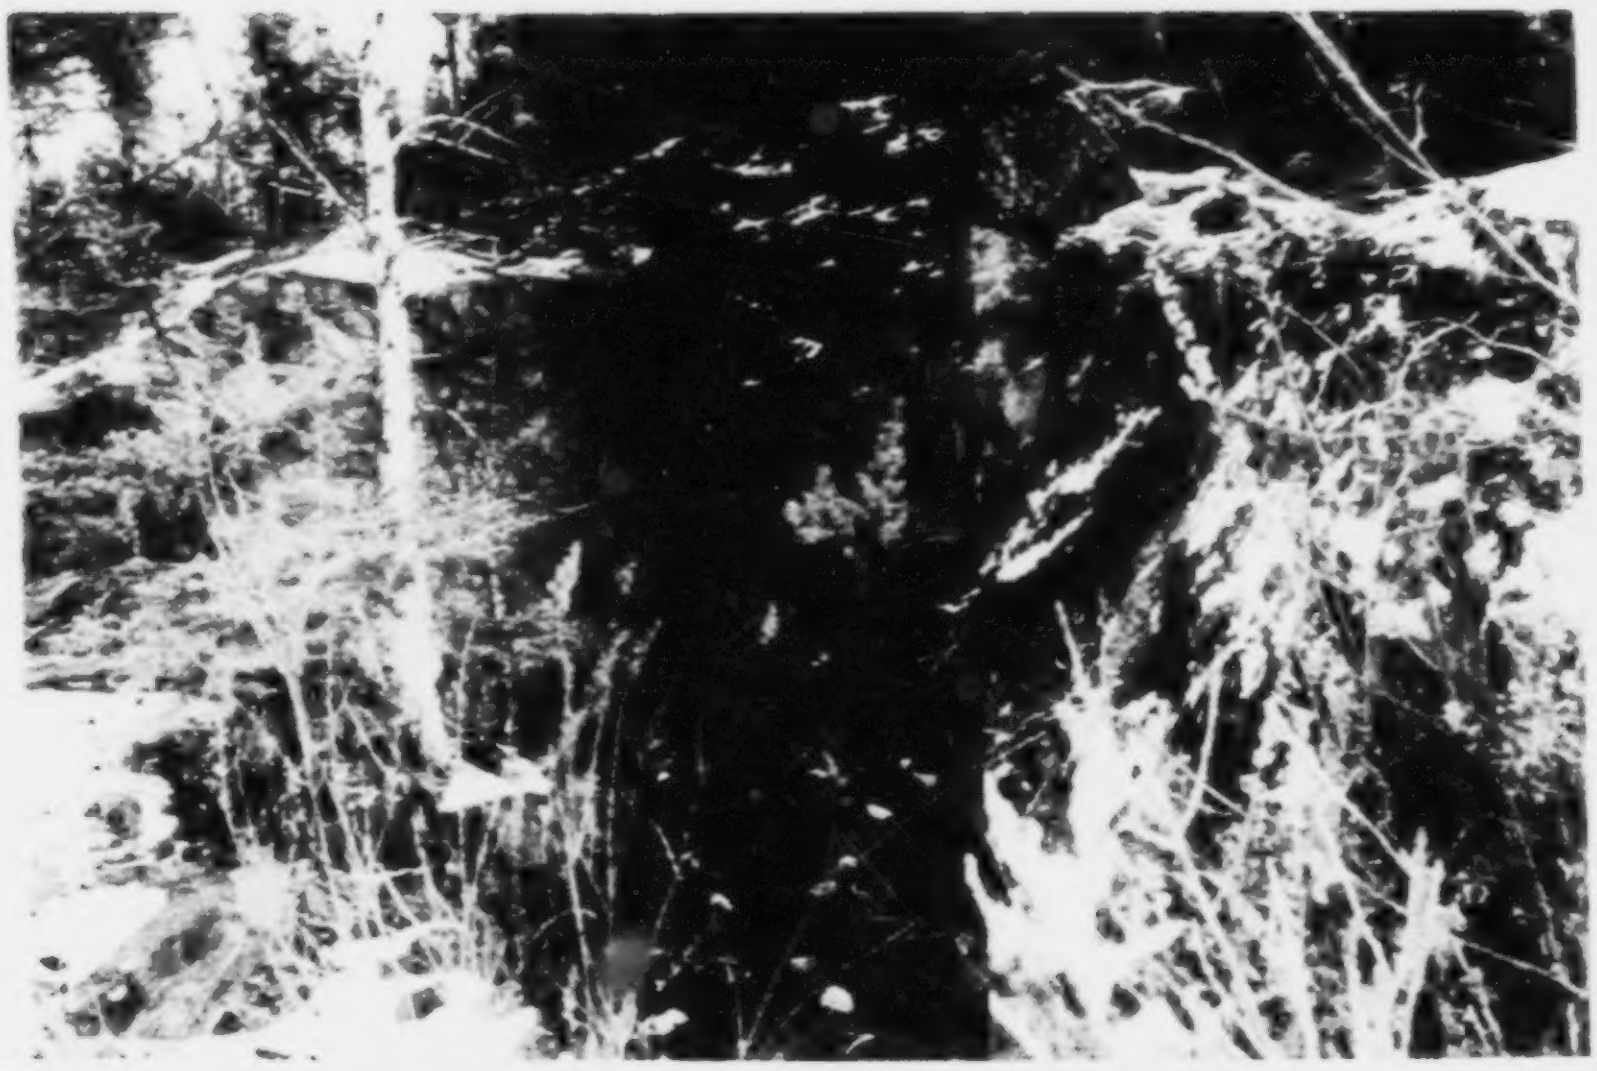
Photograph 6.16-3. Hannay Deposit Trench 'A'-October 22, 2002

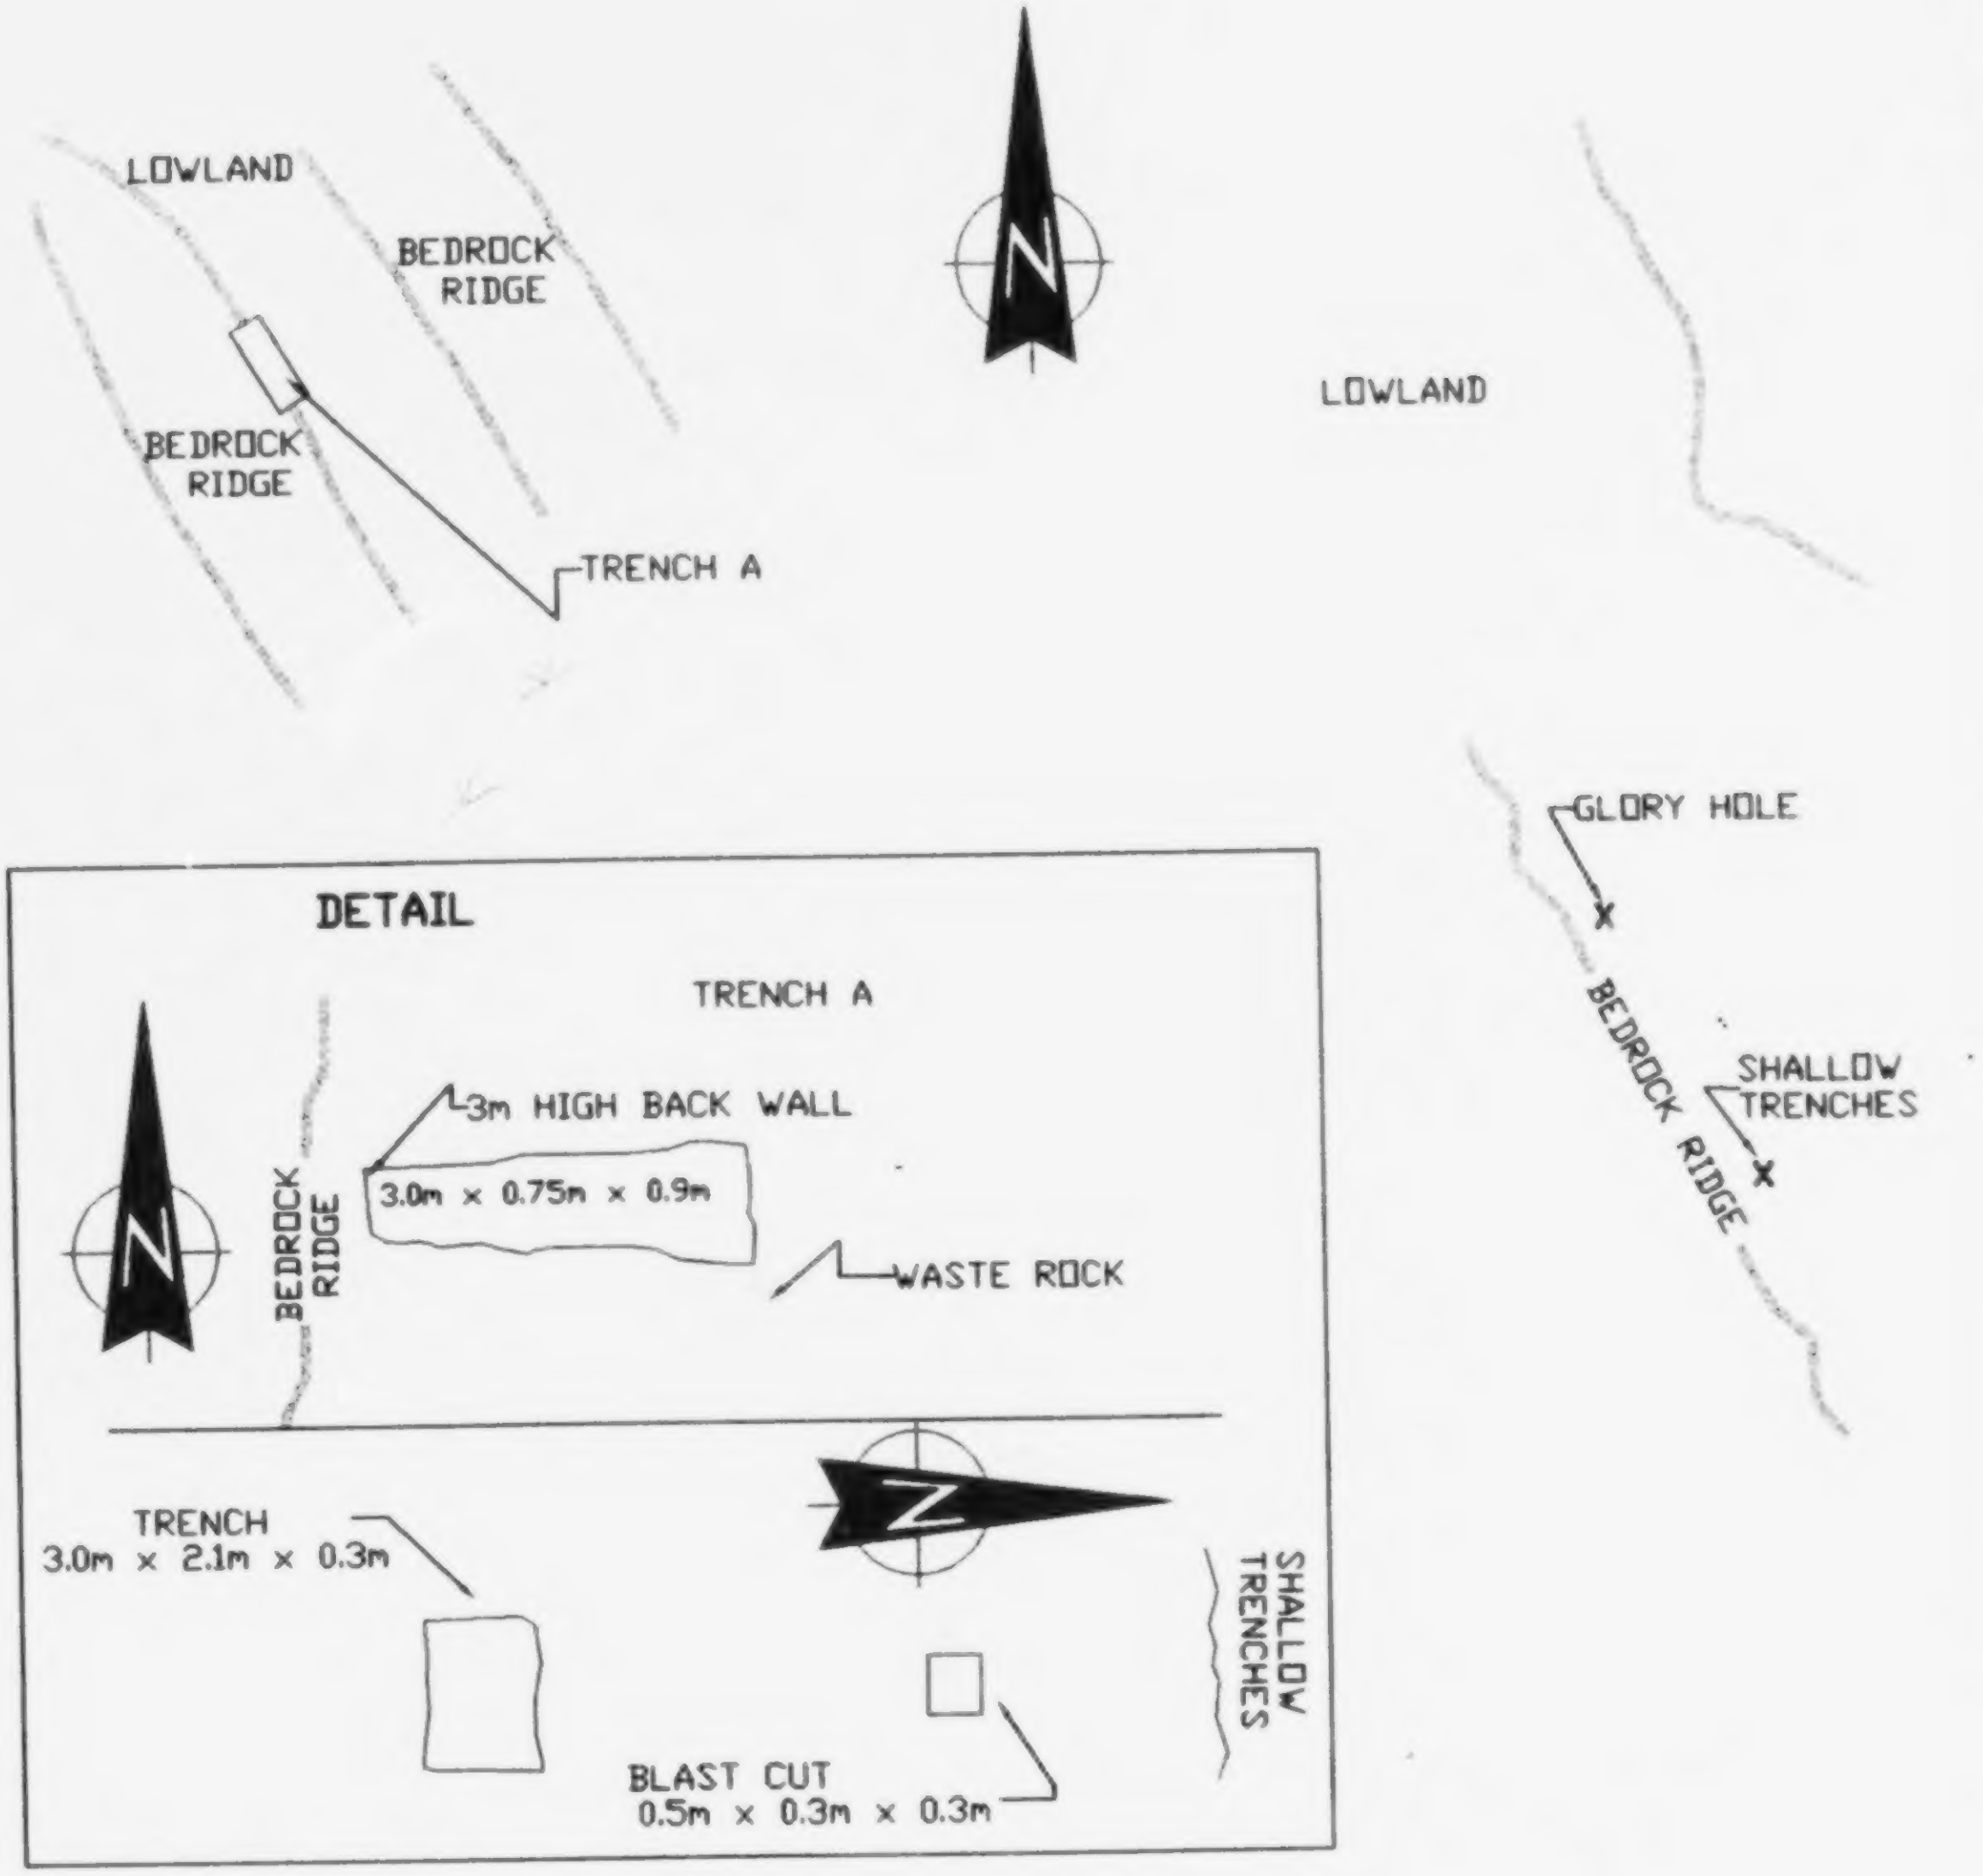
R3278\FIGURE6.17-2.DWG

At the "Hill Top Workings", a shallow trench with dimensions of 2 m x 3 m and depth of 0.3 m was observed. Close by was a small pit about 0.3 m square and deep, which appears to have been blasted to obtain a rock sample. Overburden moss and vegetation appears to have been stripped off the outcrop in areas. Approximately 60 m northwest is a small excavation (2 m x 1 m) into overburden along the hillside which exposes sheared rock for sampling.

The trenches do not pose a serious public safety or environmental hazard due to their shallow depths, open visibility, and distance from the shoreline. There was no evidence of standing water in the trenches.

No follow-up work is required for this site. The site is distant from view and from recreational tourist access, and the workings are shallow.
